1994 Northridge Earthquake

Performance of Structures, Lifelines and Fire Protection Systems

NISTIR 5396

March 1994
Building and Fire Research Laboratory
National Institute of Standards and Technology
Gaithersburg, MD 20899

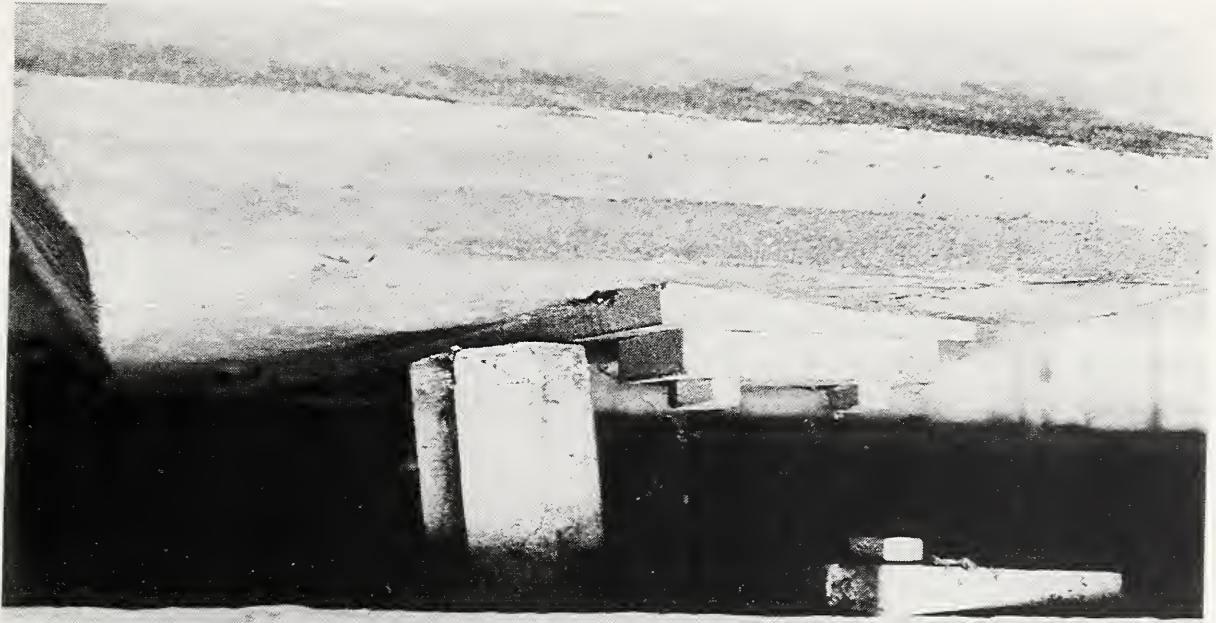
Figure 4.49 Displaced bearing block in rocker-type bearing

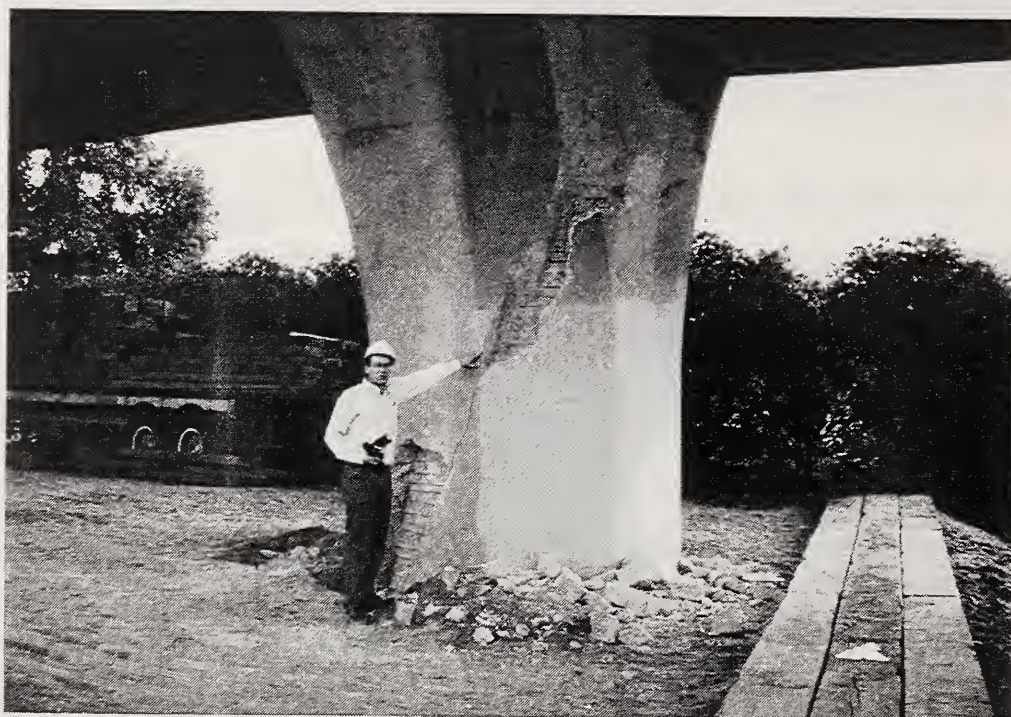
Figure 4.51 View of the westernmost pier at the Interstate 5, State Route 118, Southwest Connector, looking to the southeast. Loose cover concrete has been removed by Caltrans.

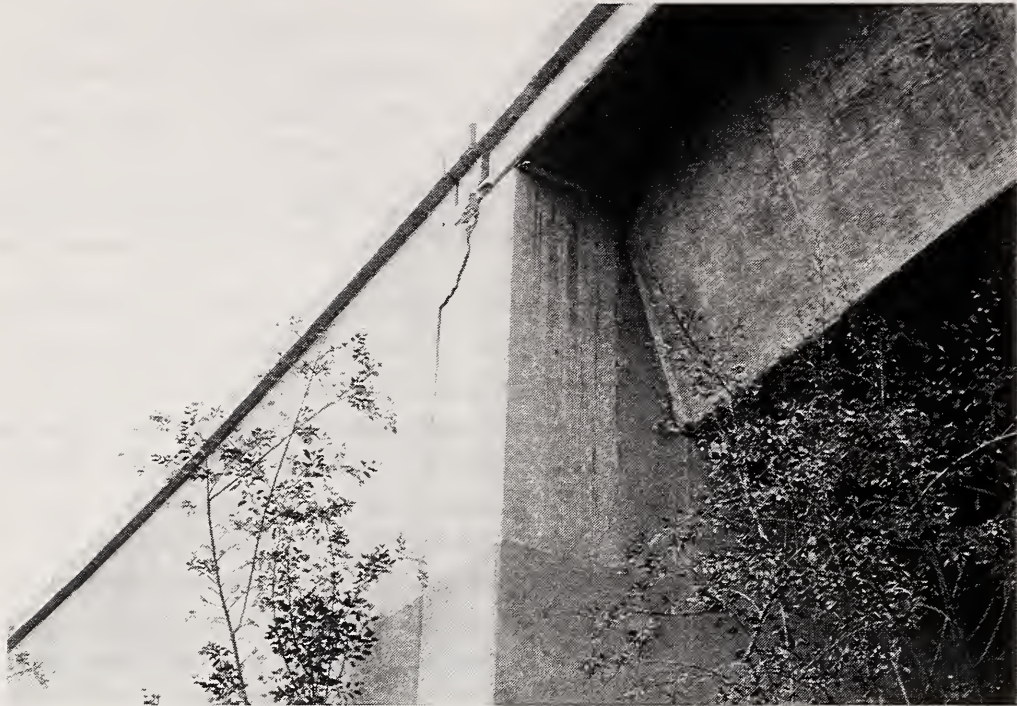
Figure 4.57 Close-up of abutment wall cracking at the east end of the ramp connecting eastbound SR118 with northbound I210

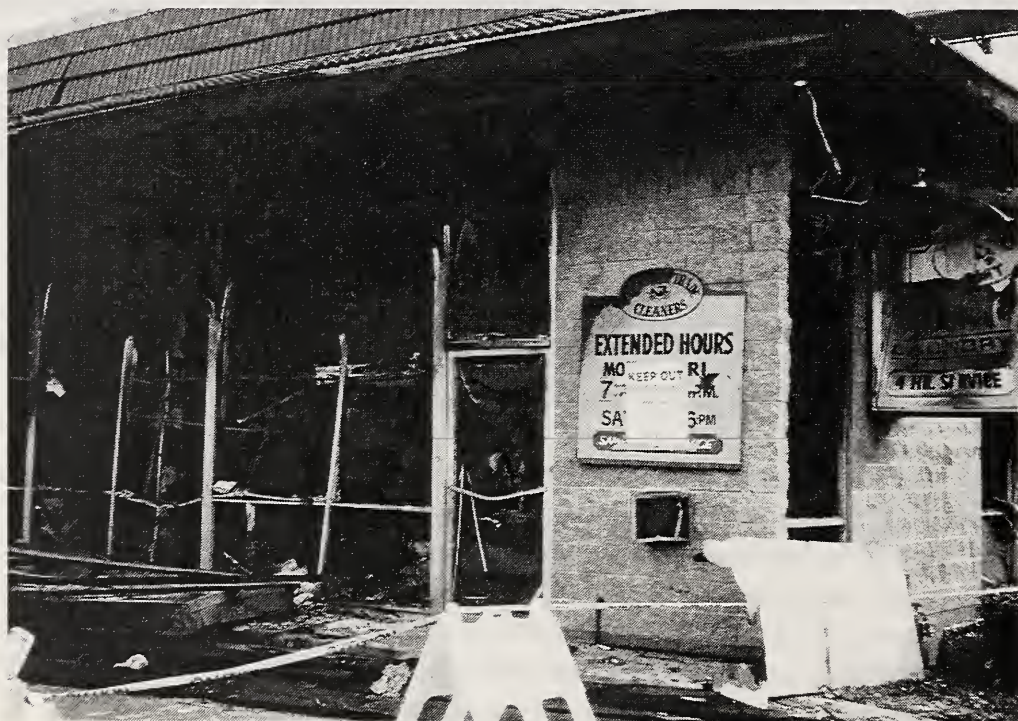
Figure 6.1 Fire damage in a single story commercial building.

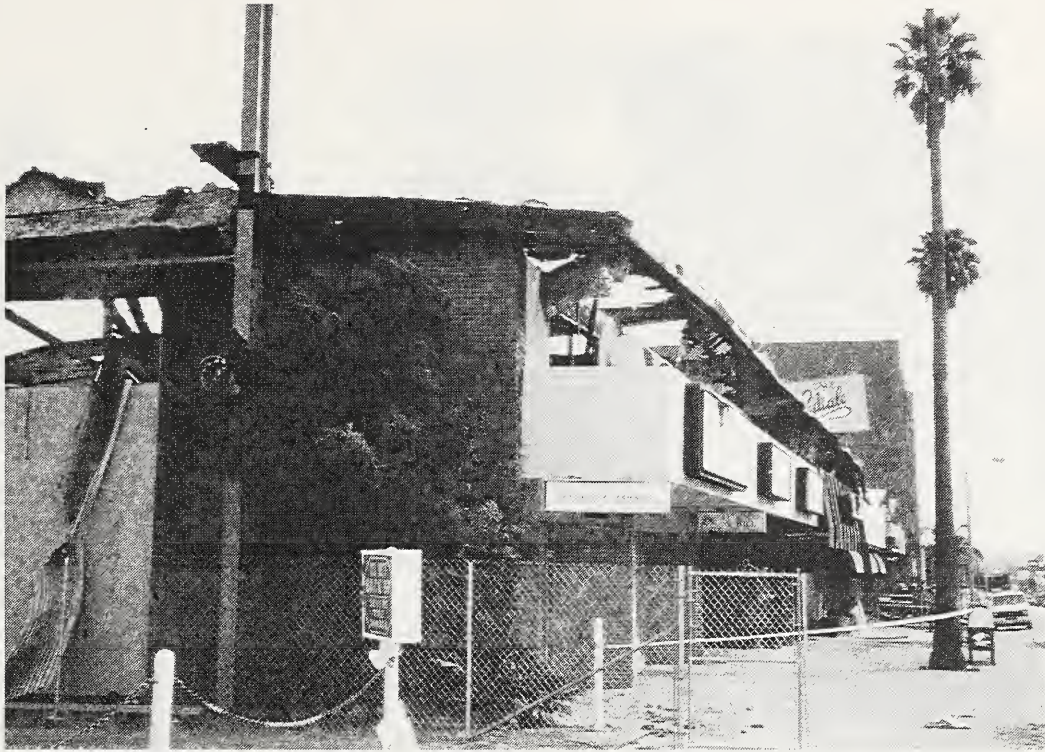
Figure 6.2 Fire damage in a two story commercial building.

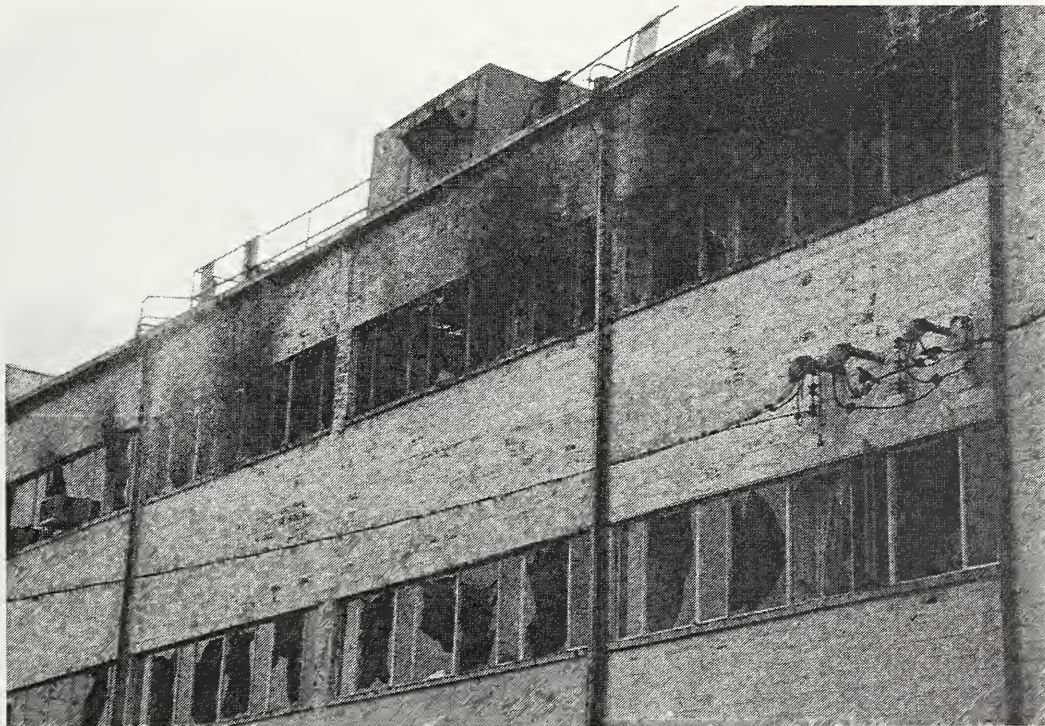
Figure 6.3 Fire damage in a three story commercial building.

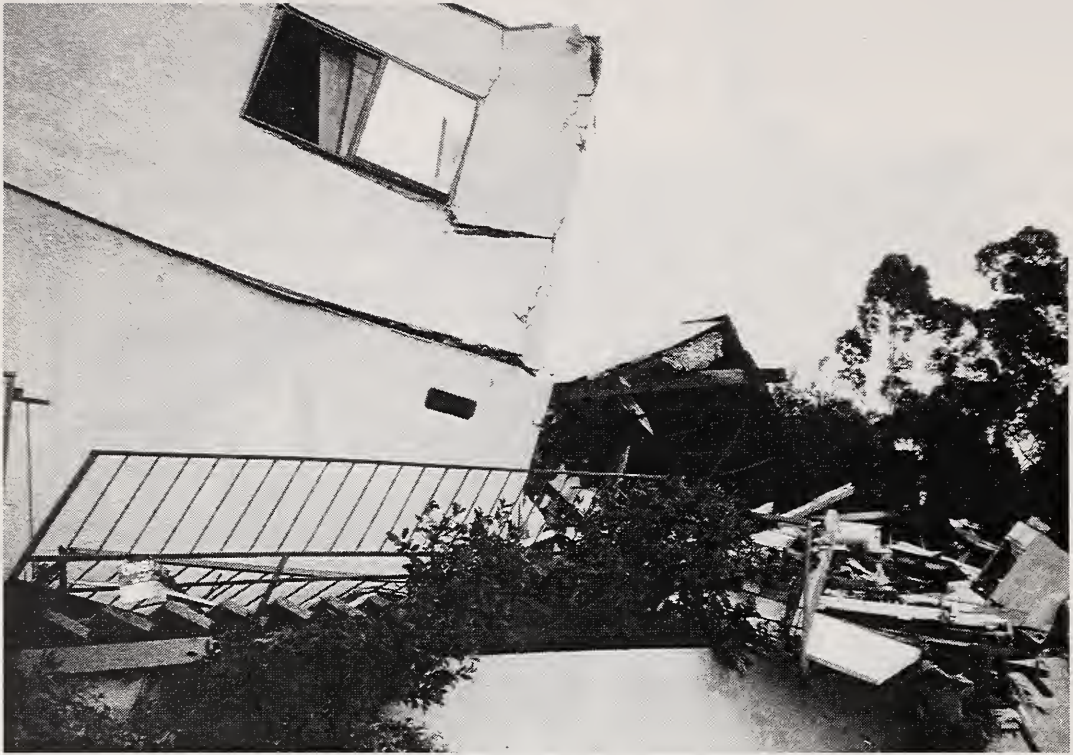
Figure 6.4 Partially collapsed apartment building with fire damage in the rear.

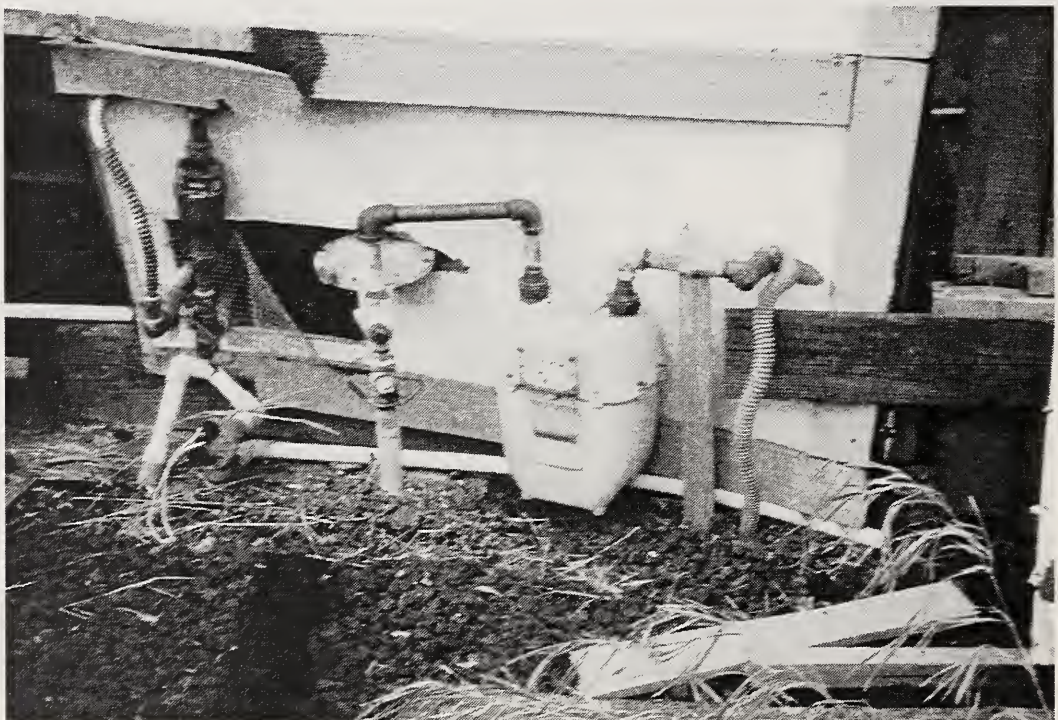
Figure 6.5 Damaged gas service in a manufactured housing development.

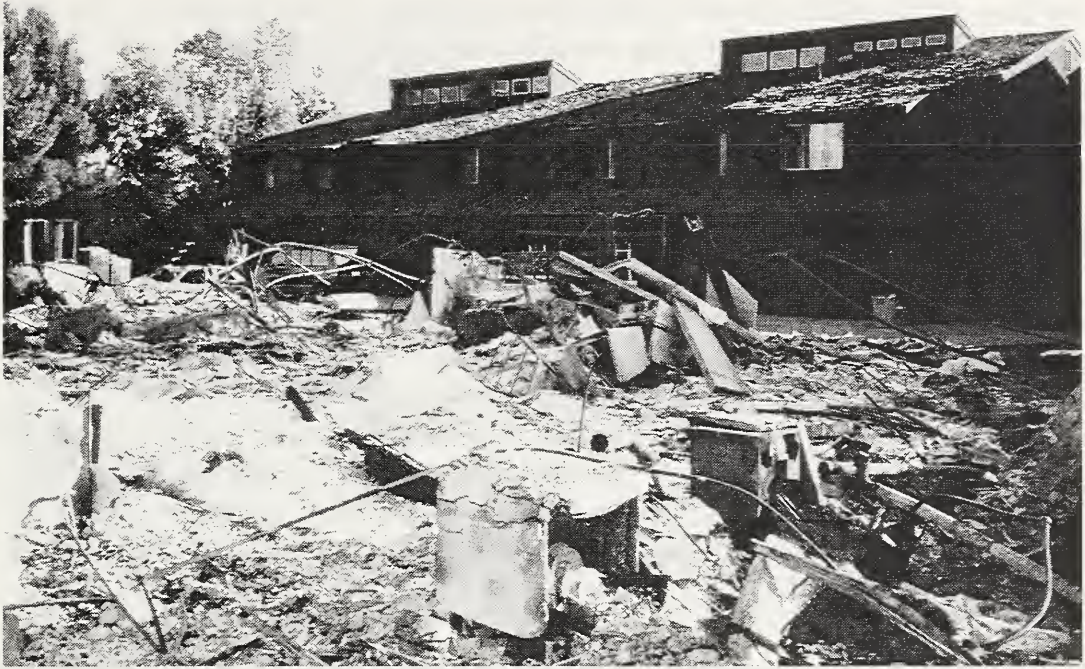
Figure 6.6 Multi-family residential building destroyed by fire.

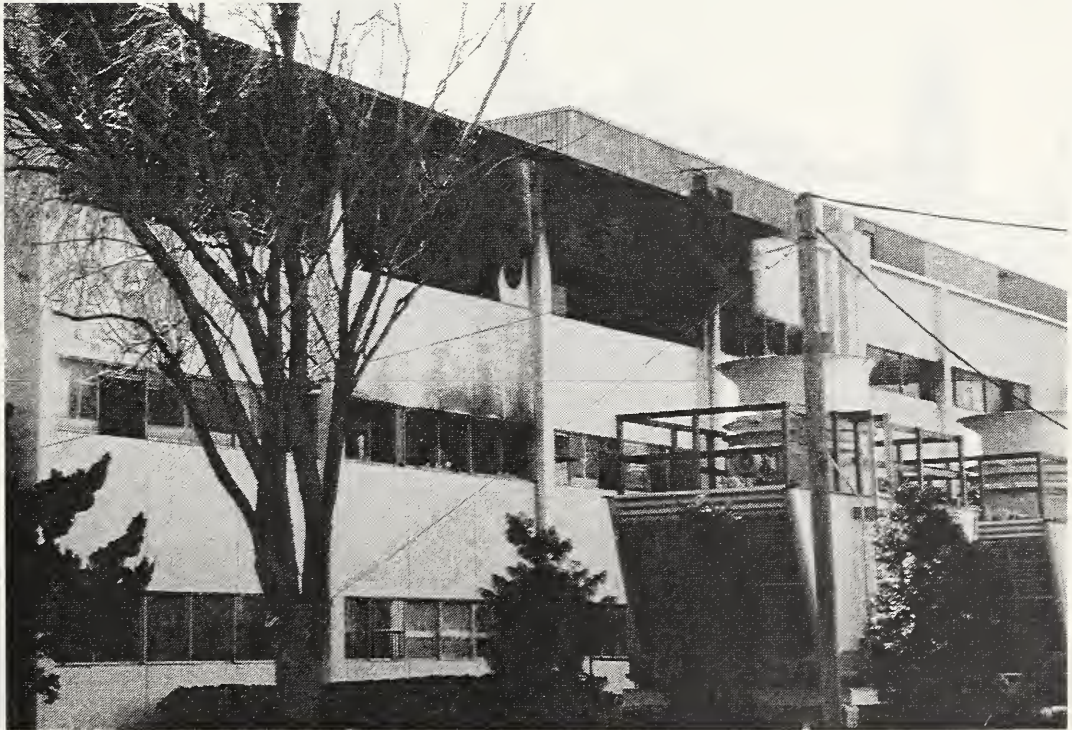
Figure 6.7 University science building damaged by fire.
